Remedy Effectiveness: Comparison of Remediation Technologies

Thin Layer Dredging and Capping

Recent Case Histories

William Elmer, PE, Foster Wheeler Environmental Corp

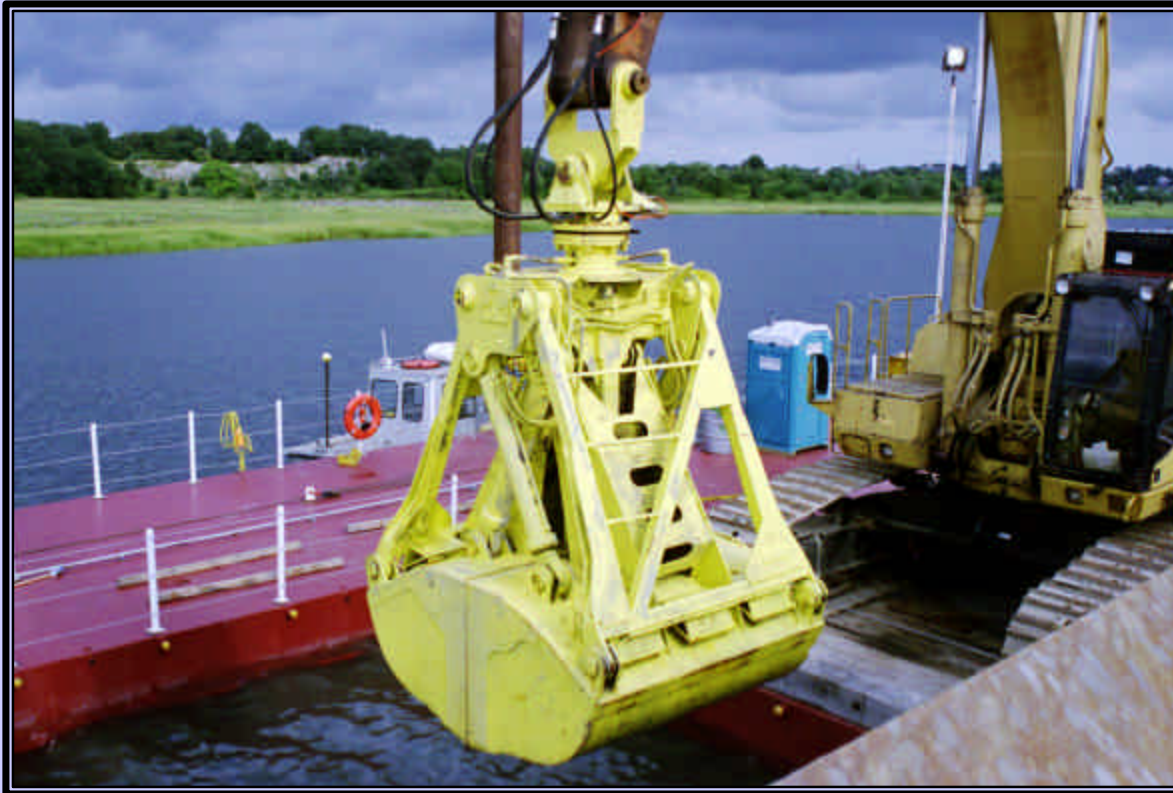
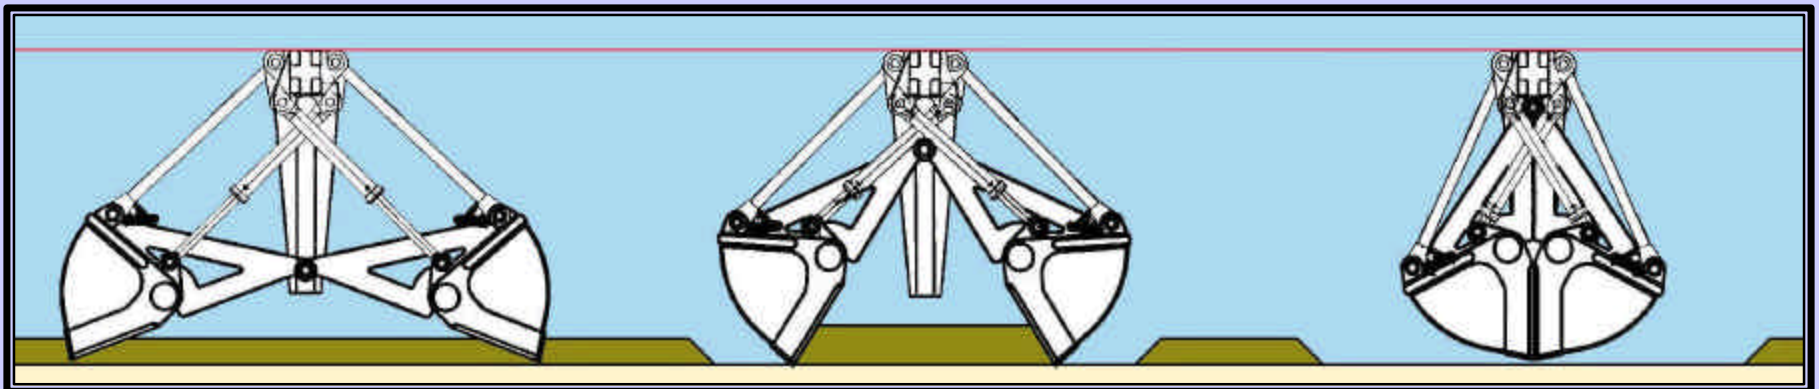
Horizontal Profiling Grab Bucket

- 4.5 cy Bucket
- Full Range of Motion
- Hydraulic Closure
- Sealed Edges
- Level Cut

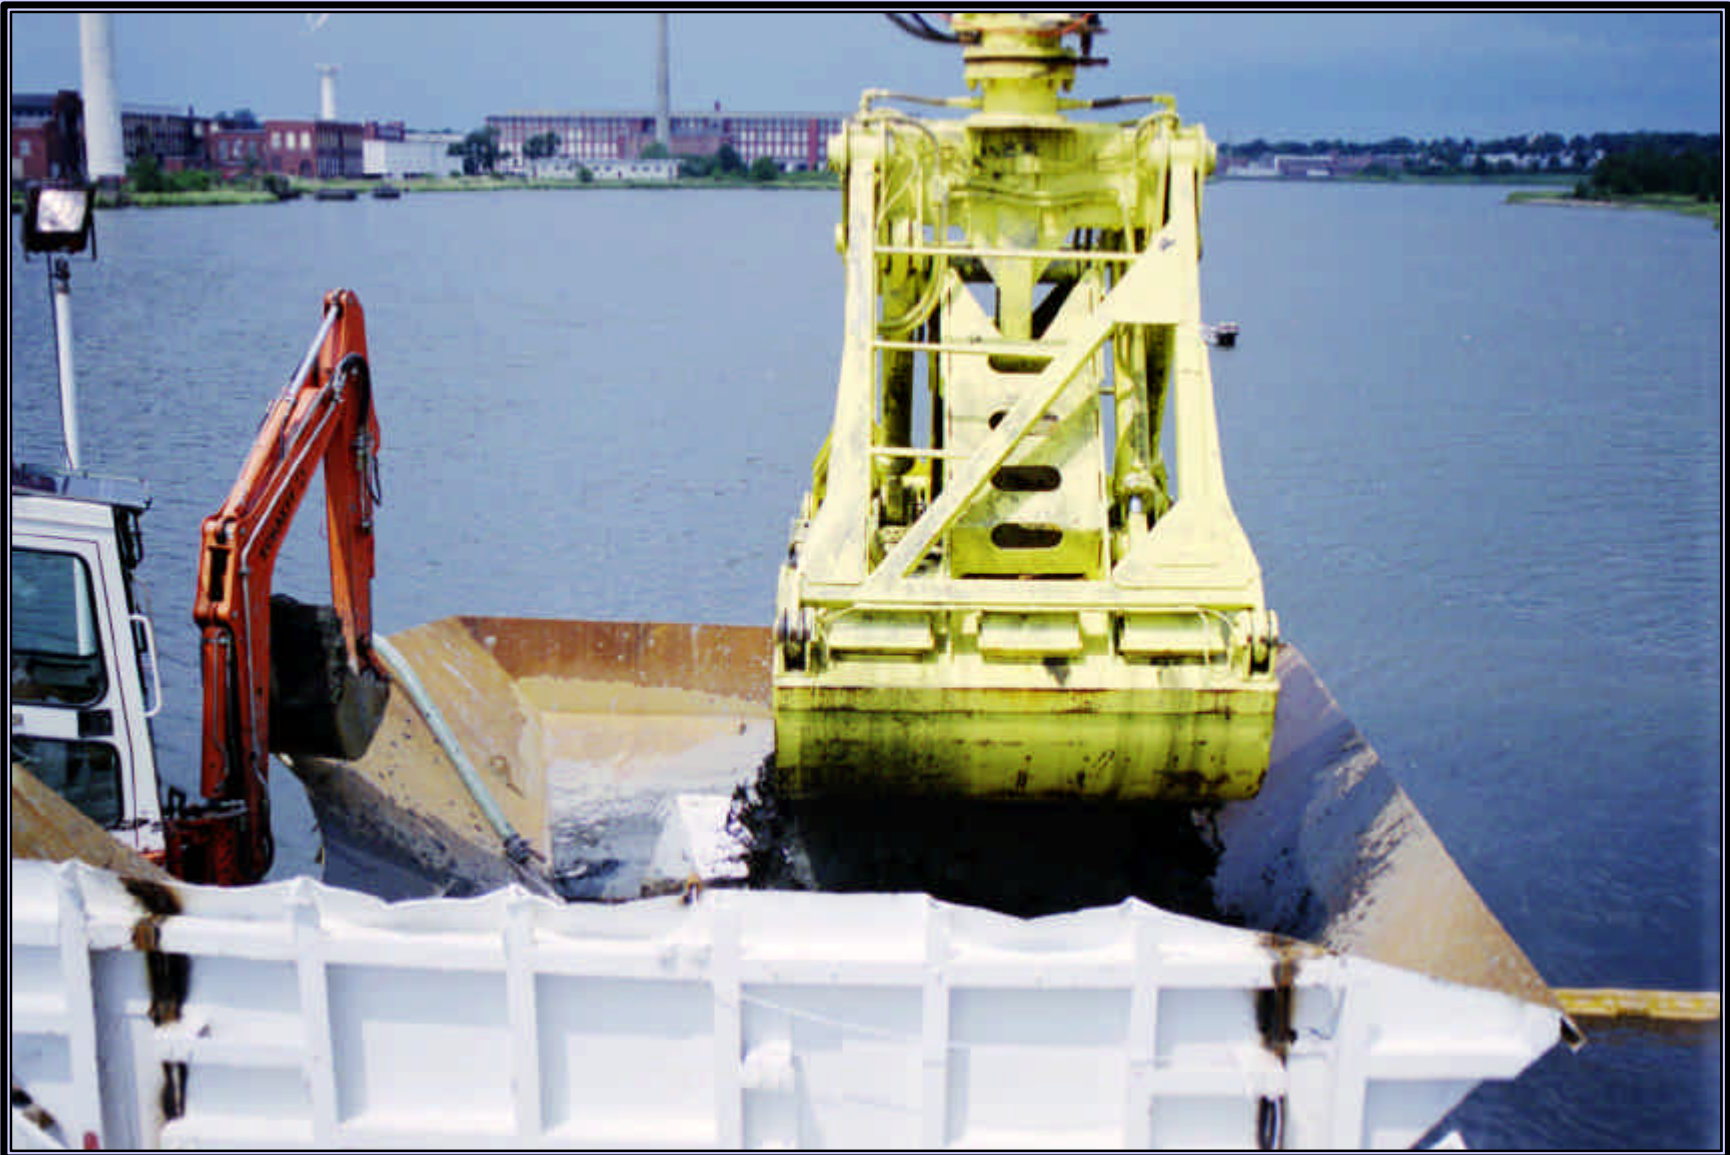
Dump into Hopper/Grizzly

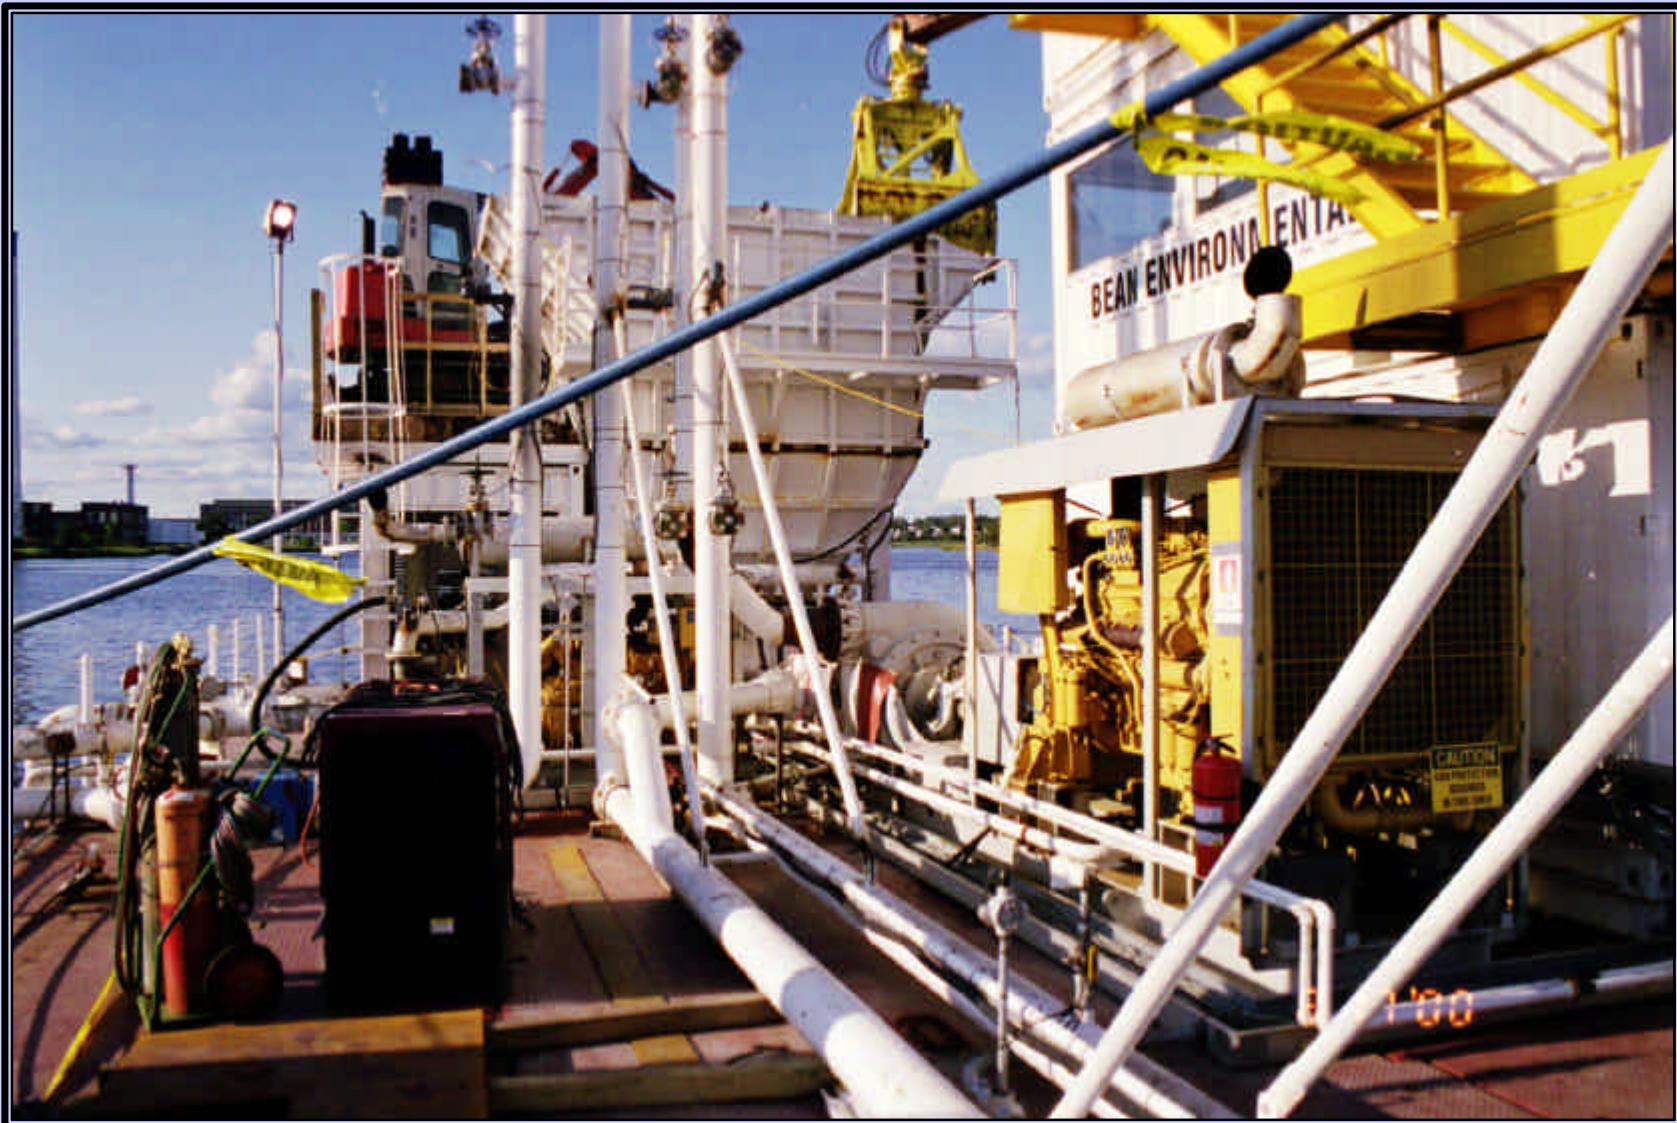
Water Injection at Patented Slurry Processing Unit

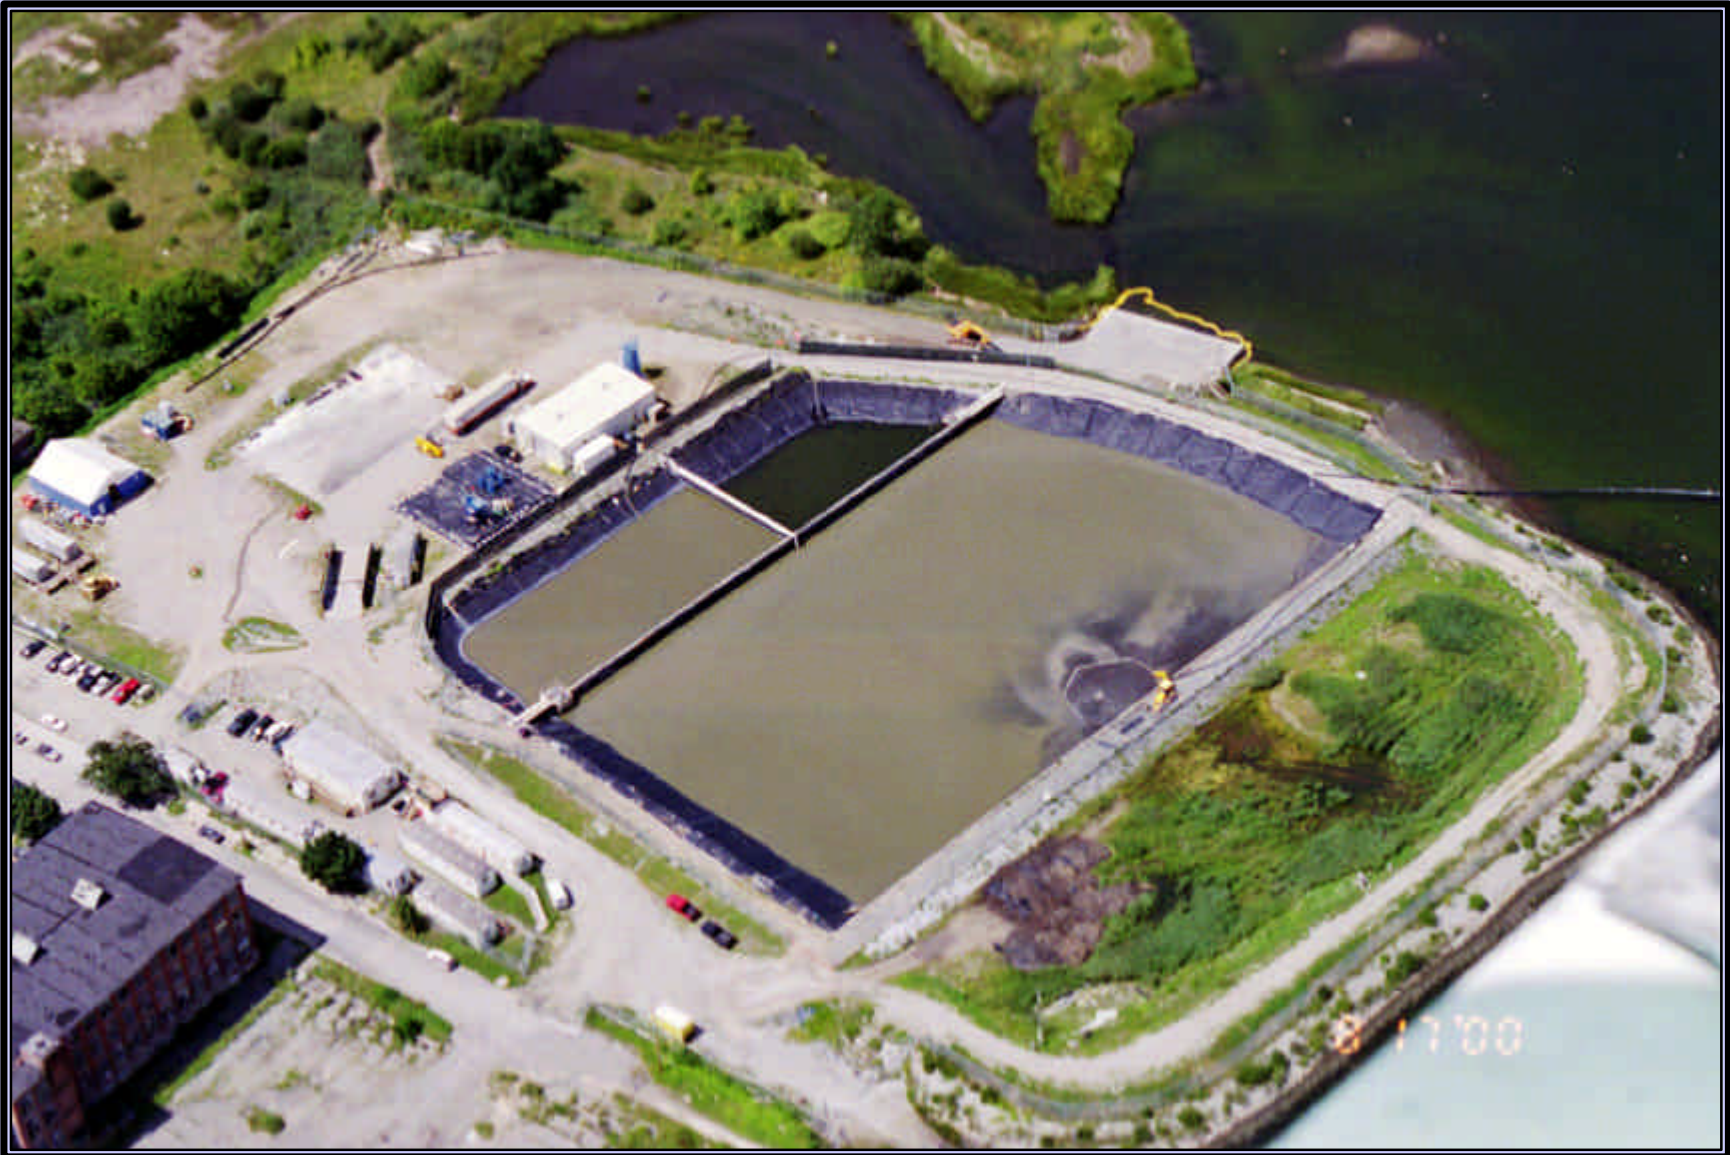
Pipeline Slurry Discharge to CDF

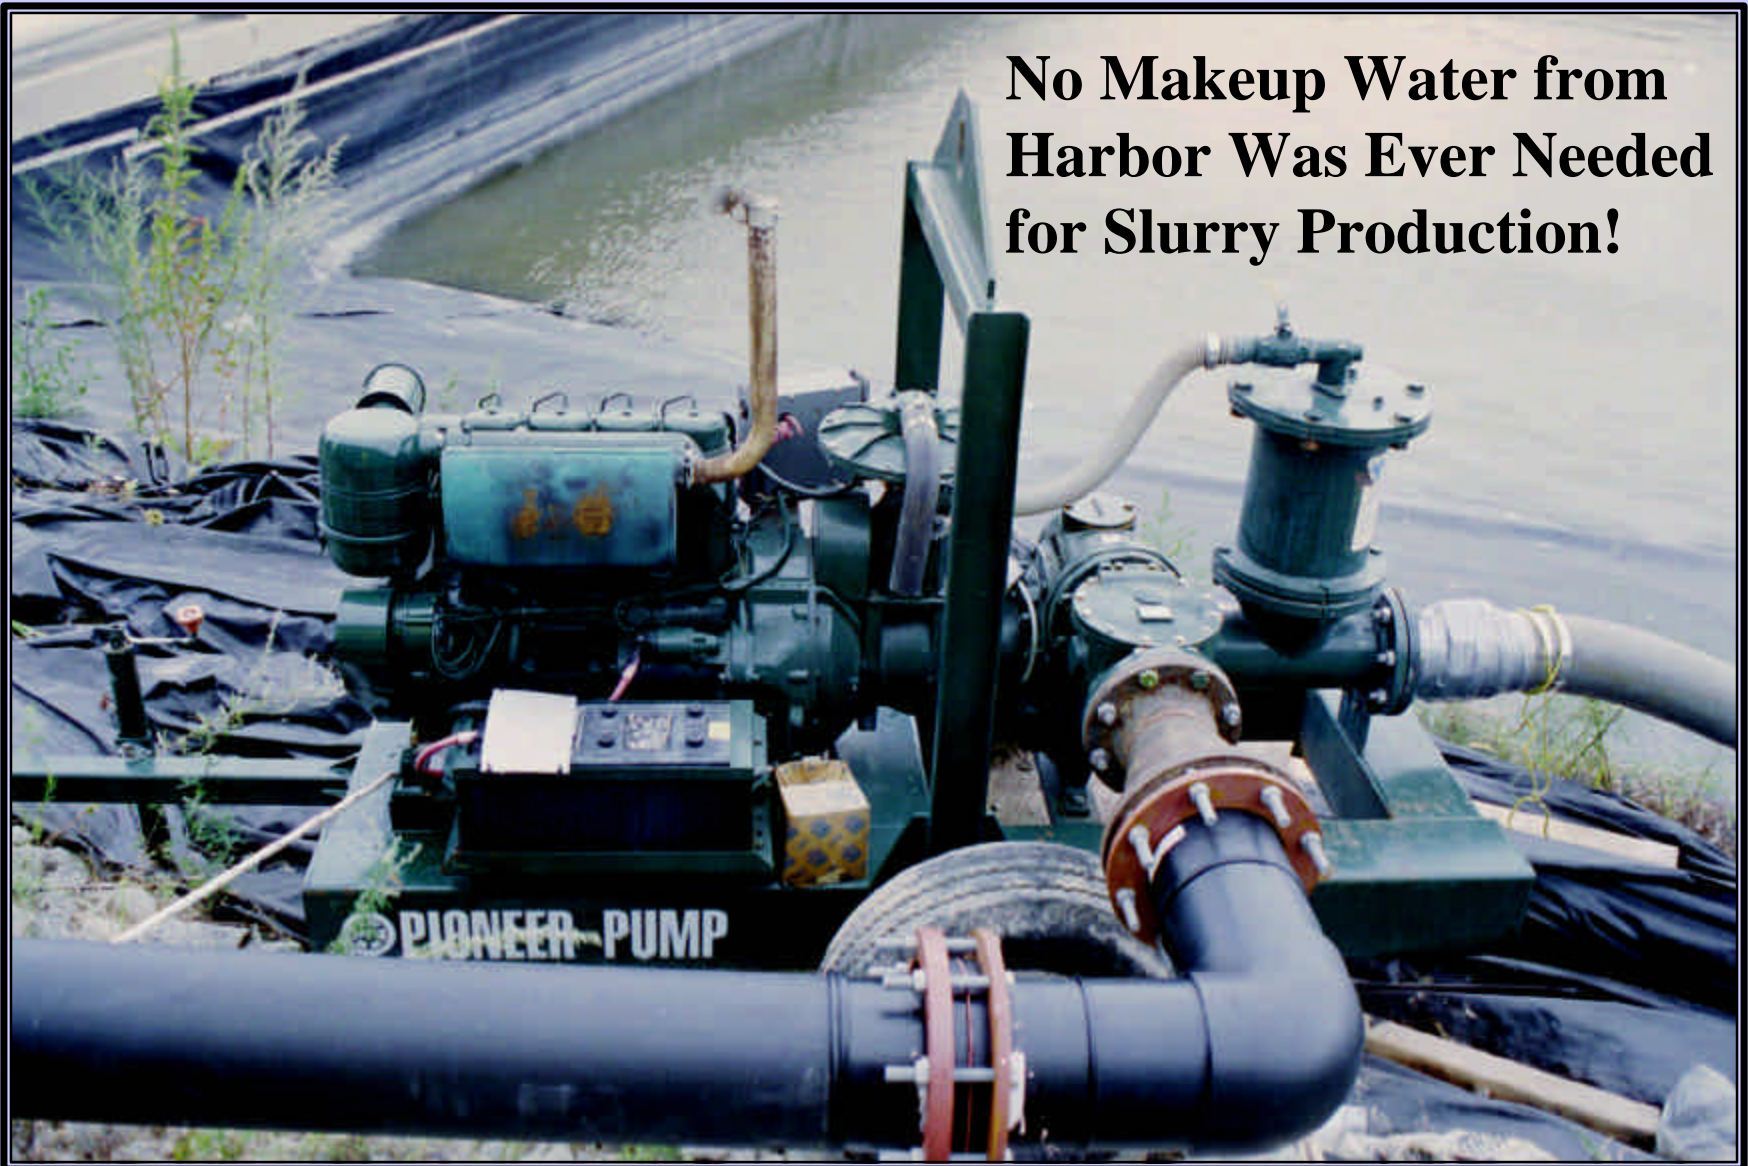
Re-Circulation System

No Makeup Water from Harbor Was Ever Needed for Slurry Production!

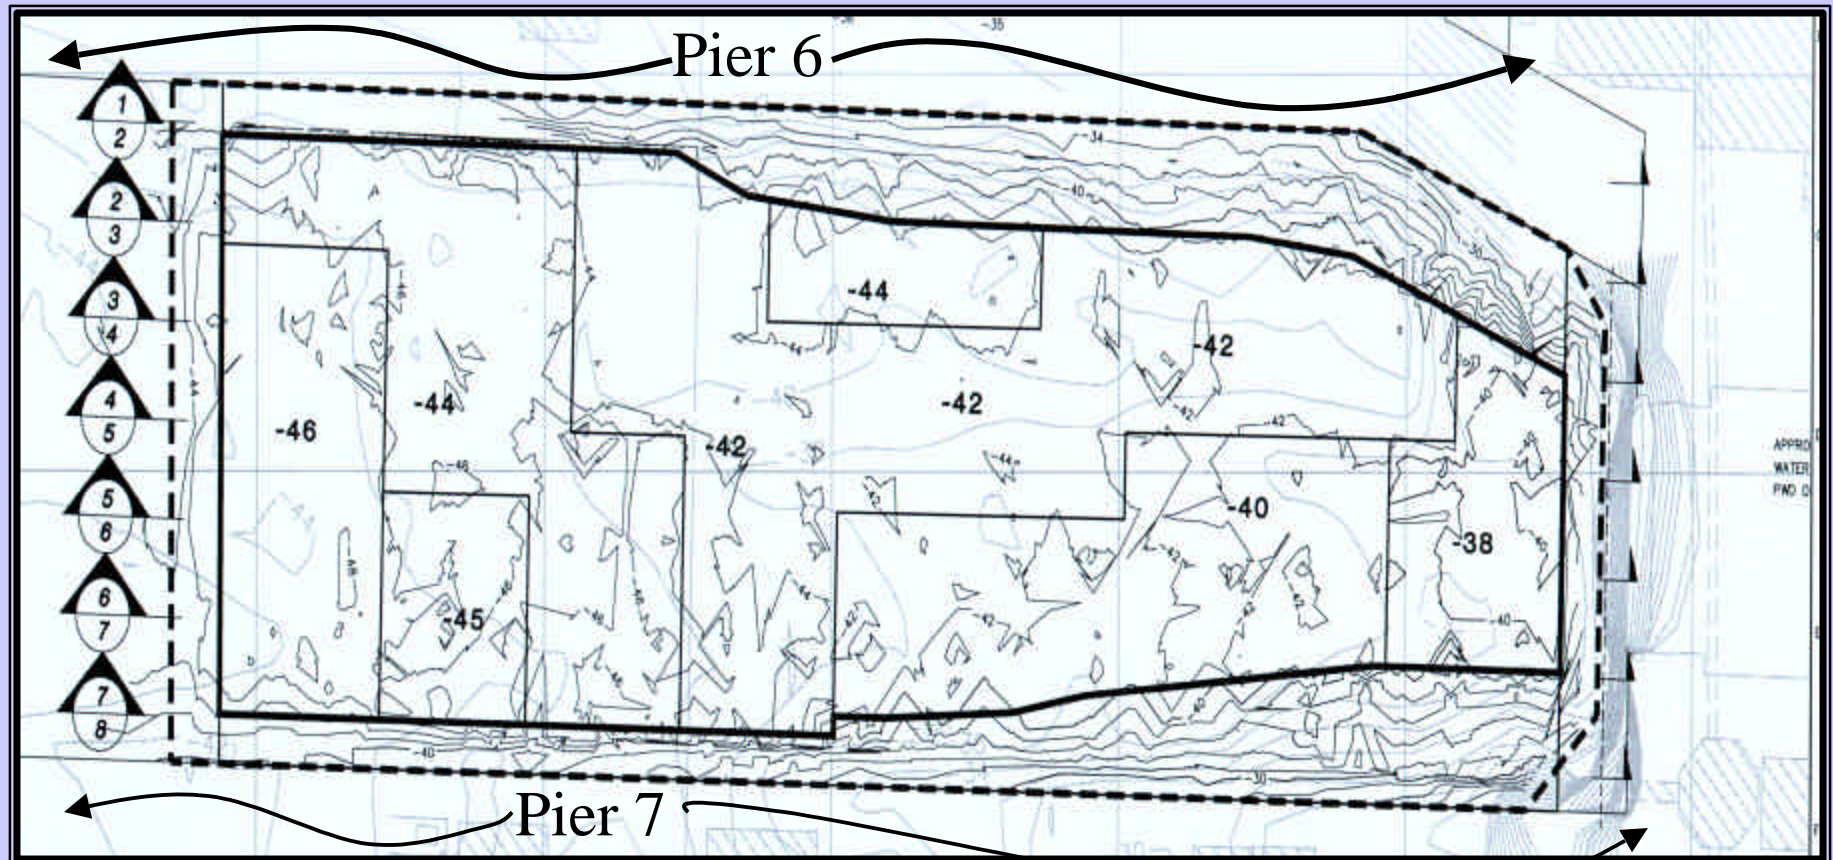
Complex Dredge Plan/Tight Quarters

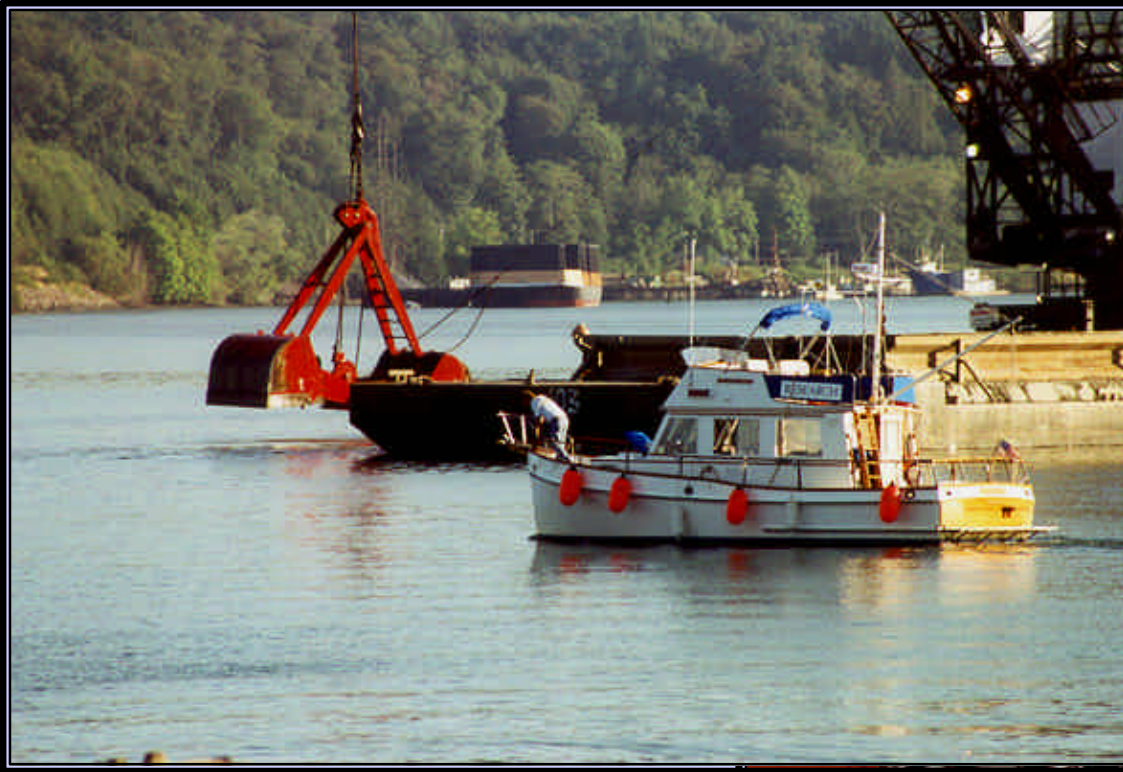
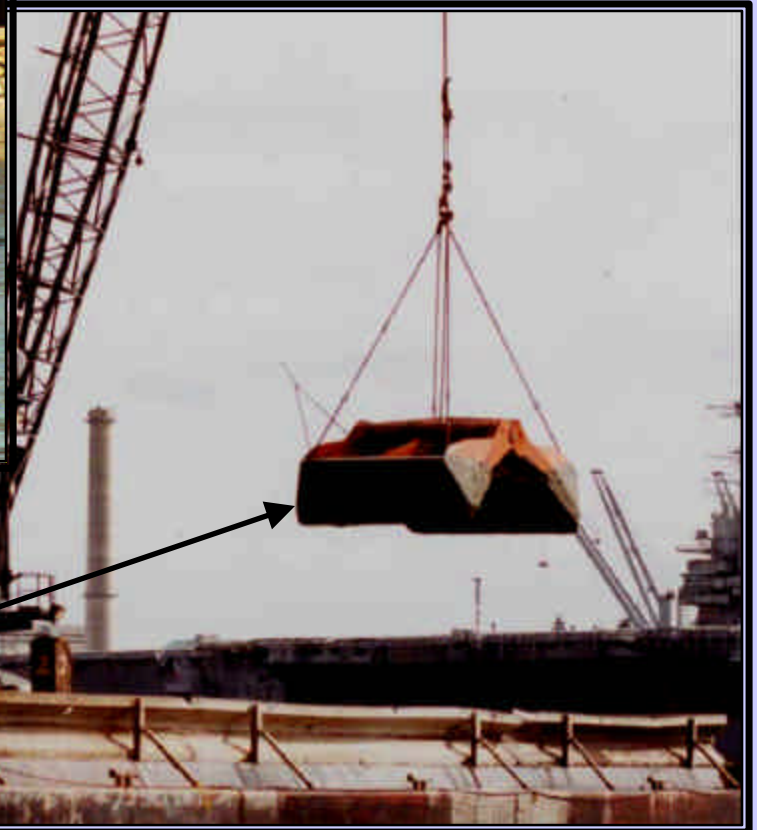
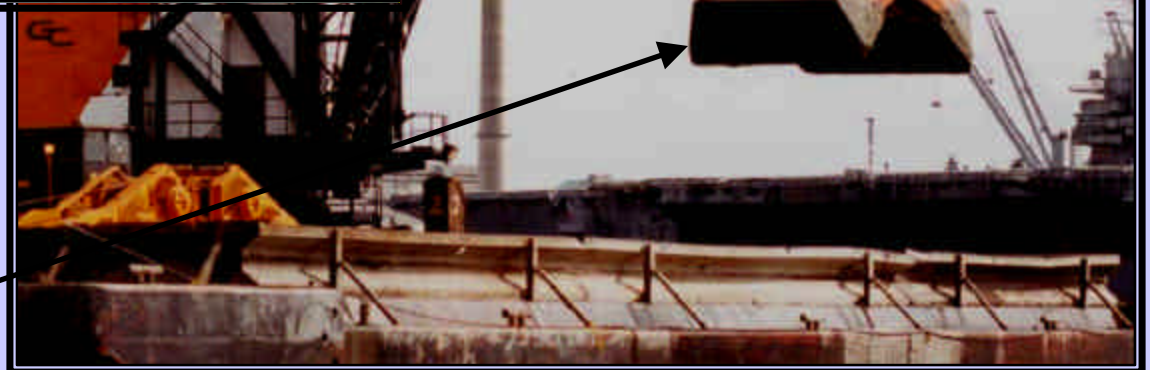
Used Two Types of Buckets

No Difference in
Capability or Effective-
ness Noted

Subcontractor Liked
This Style Better

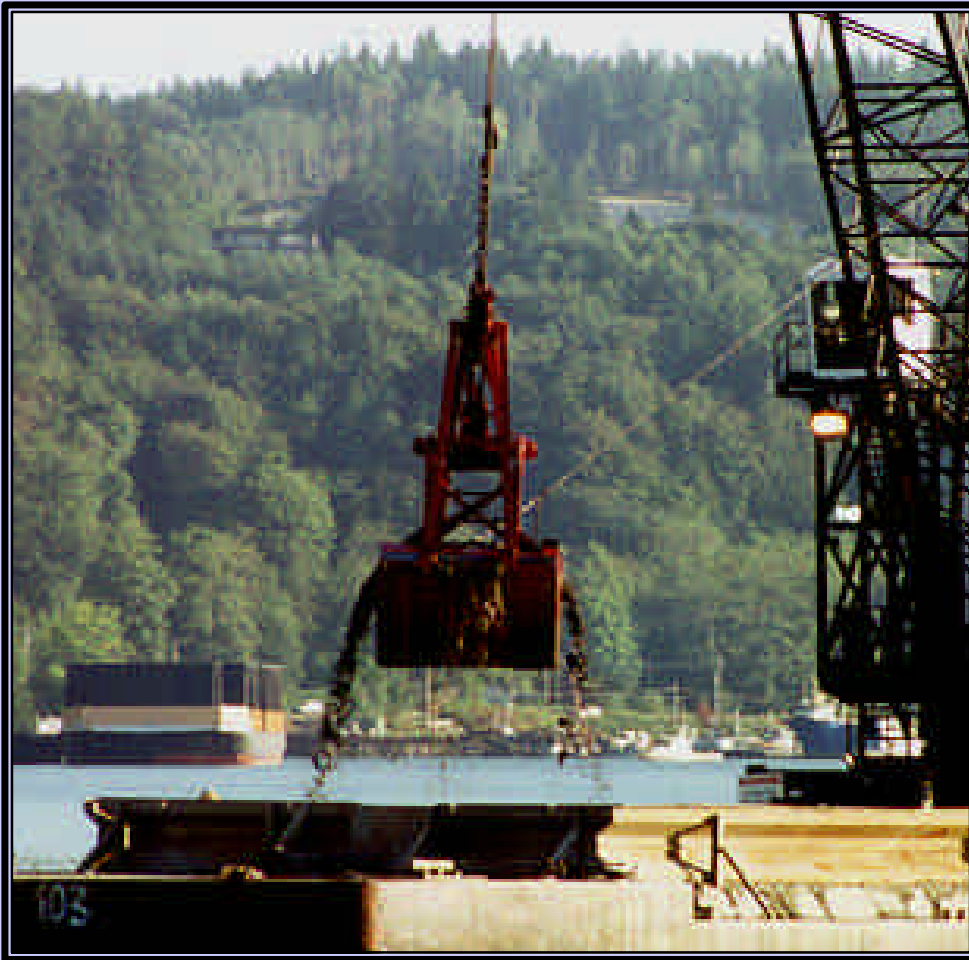
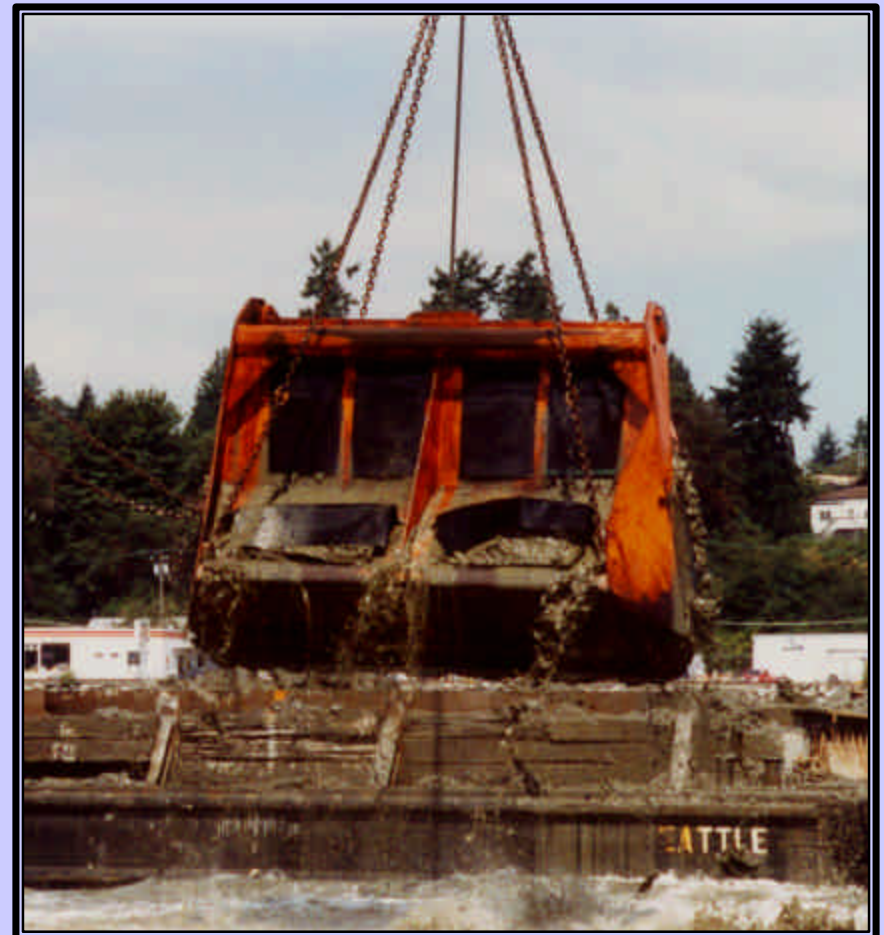
Overfilling = Spills from Vents

Which Can result in
Water Quality Problems

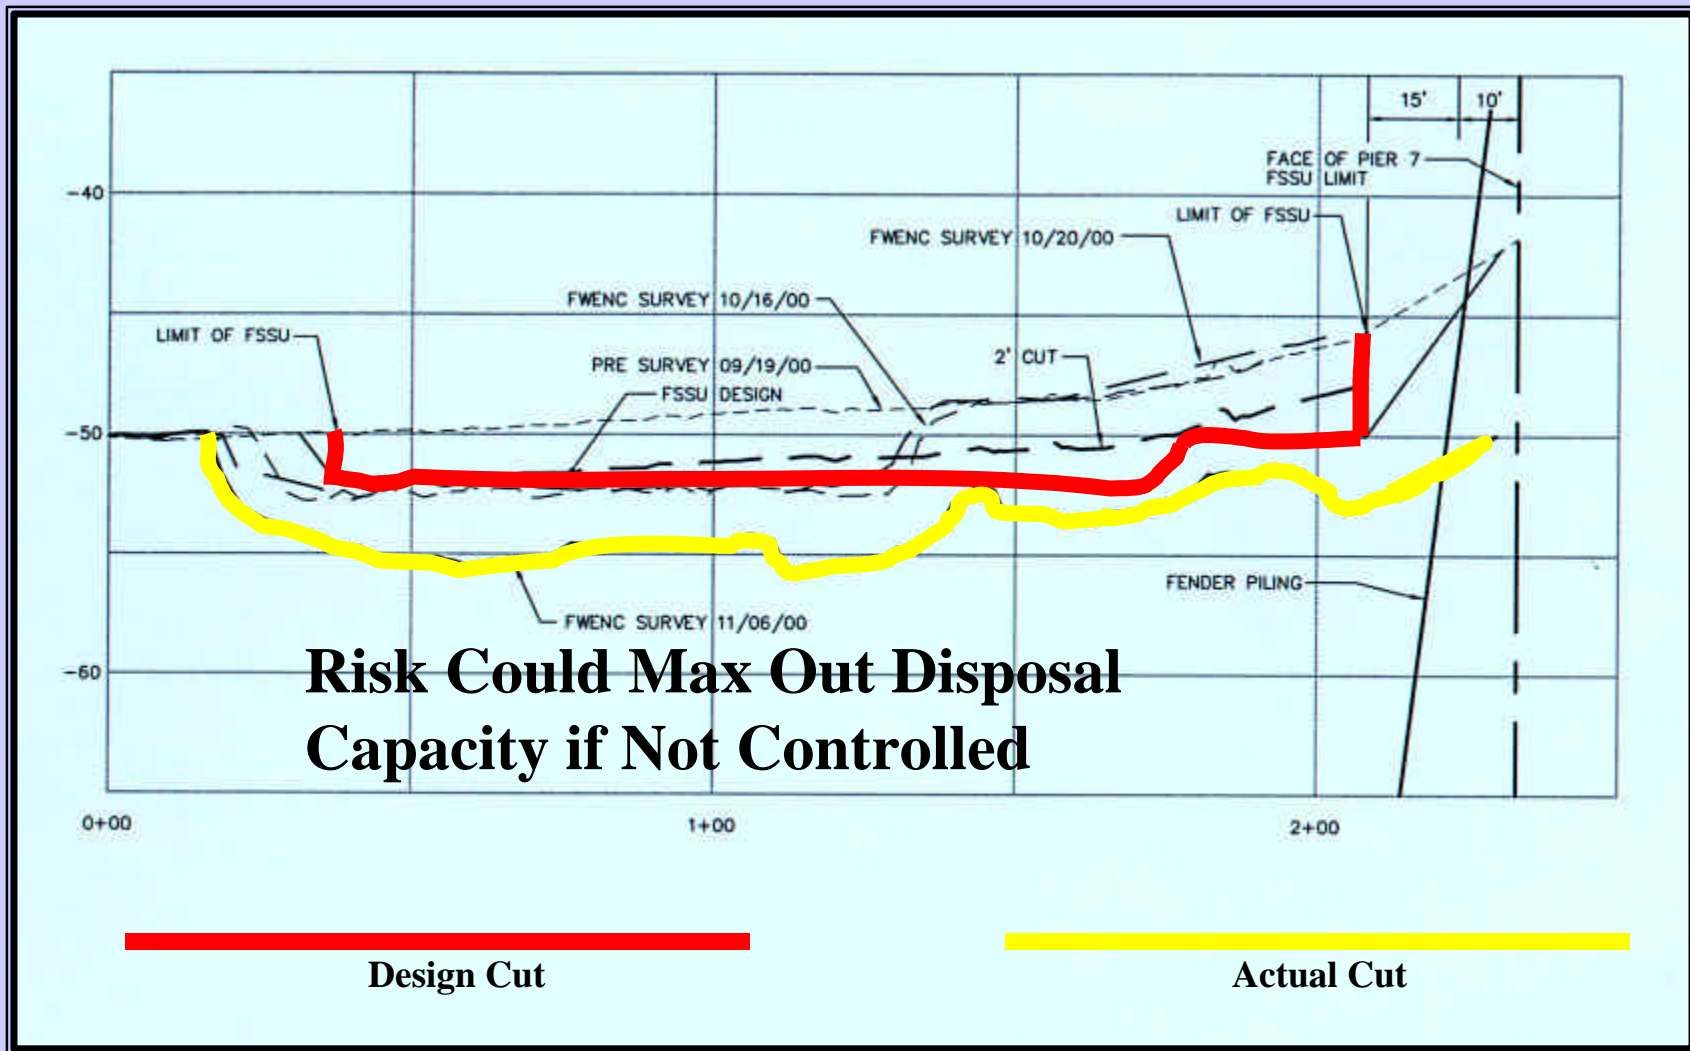
Example of Overexcavation

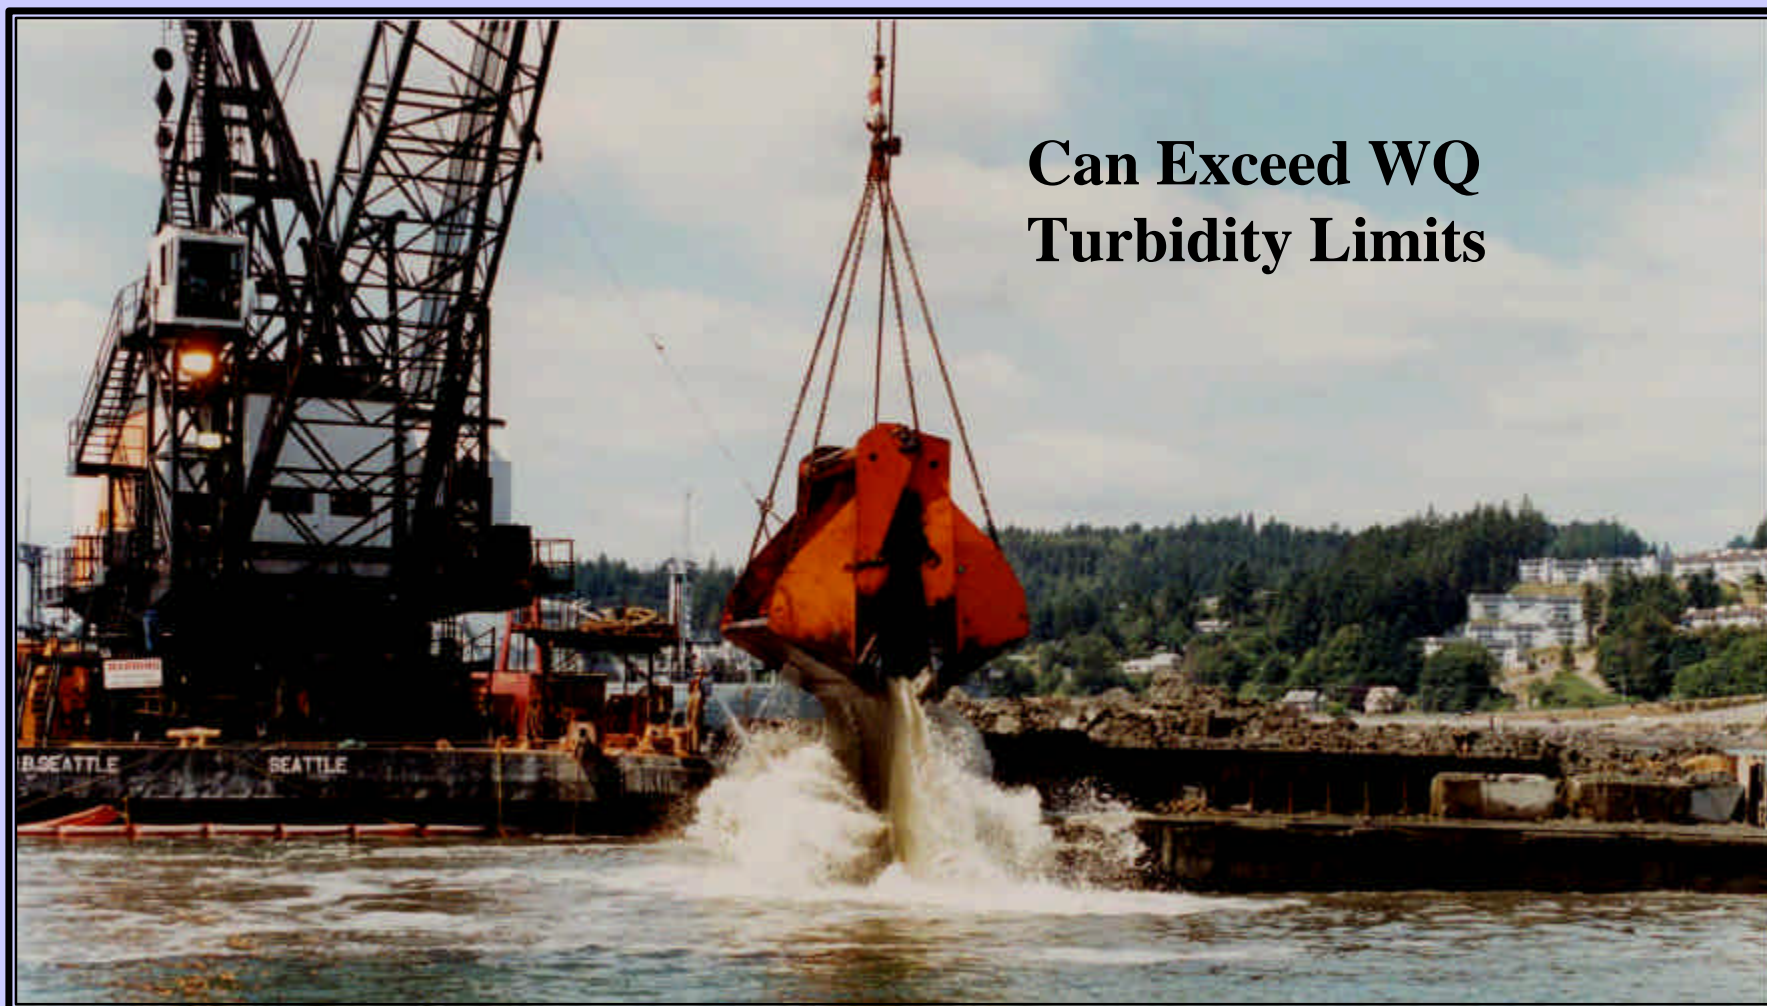
Prevent Over/Under **Filling** & Ensure Full Closure

**Can Exceed WQ
Turbidity Limits**

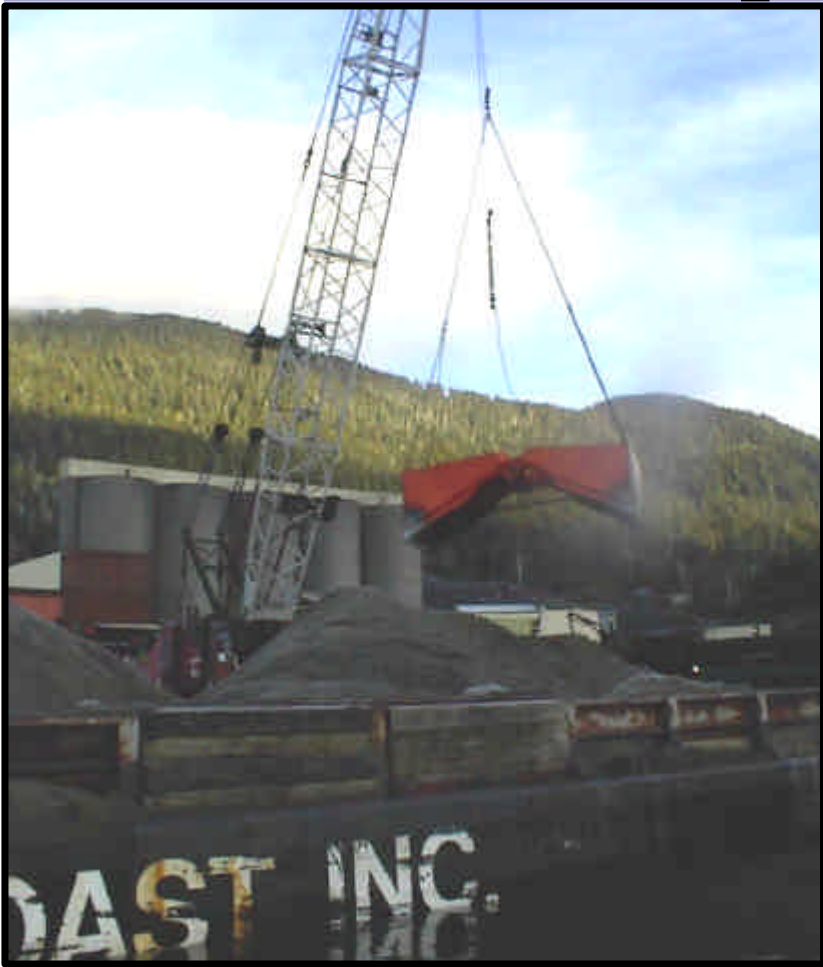
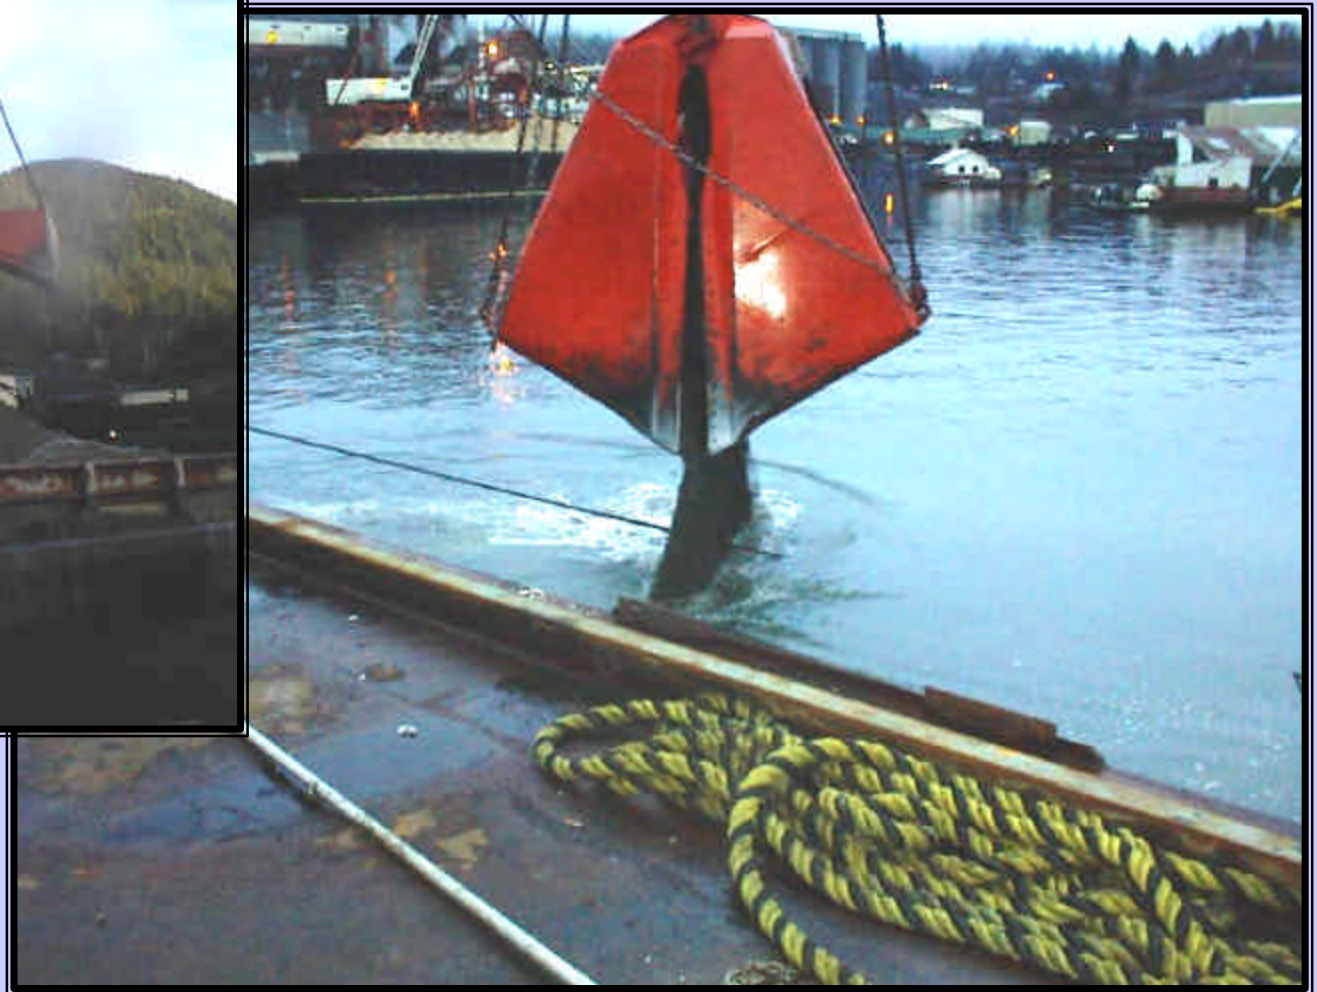
Cap Placement

- 80 Acre Area of Concern
- Relatively Small Dredging Proj (<10,000cy)
- Significant Capping Project (26.4 Acres)
 - Cap of Very Soft Organic Sediments
 - Anticipated a Multi Stage Approach to Capping
- Successfully Implemented at Stage 1 (One Pass Thin Layer Cap)
 - 6 to 9 inch Sand Cap Successfully Placed By Clamshell

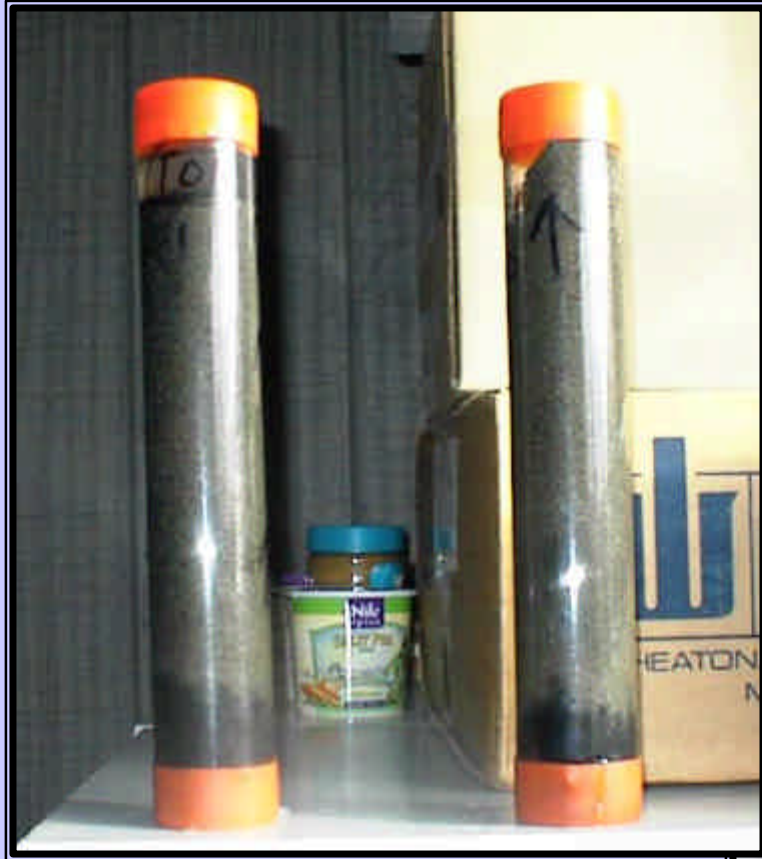
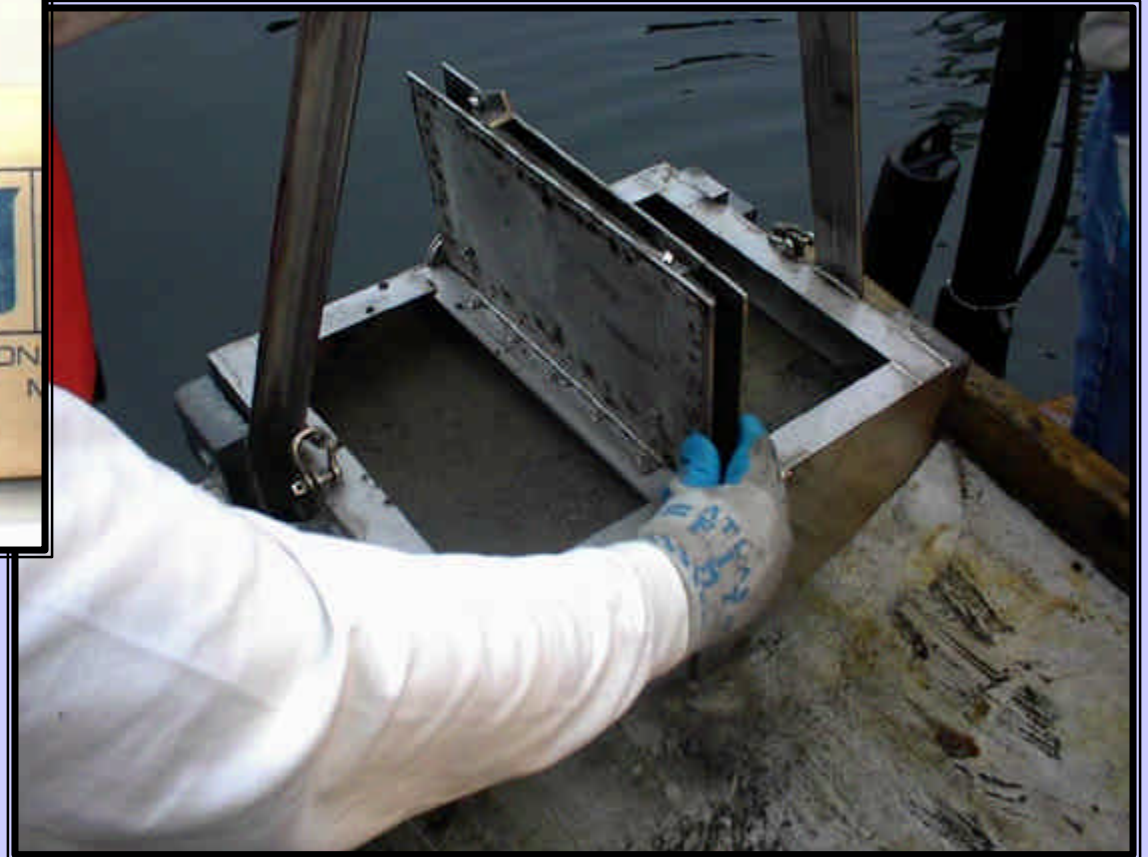
Excellent Coverage Obtained

- Possible to Place Uniform Cap on Soft Sediments with Clamshell
- Requires That a Trial and Error Approach be Used
- Success When a Close Owner/Contractor/Regulator Working Relationship is in Place to Allow Field Modifications to Meet Clean Up Objectives
